FIELD INSPECTION

Project Name:	Mountain Valley Pipeline	Inspector:	Matthew Grant
Inspection Date:	Wednesday, September 12, 2018	Project Contact:	Brian Clauto
Spread: Franklin County	Spread H	Weather (Wet/Dry/Rain):	Wet

FIELD INSPECTION PHOTO LOG

Project Name: Mountain Valley Pipeline Date: Wednesday, September 12, 2018

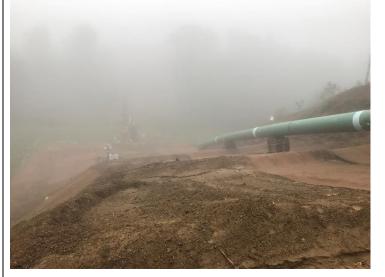
Fig. 3 In the area of MP246.43 St# 13012+00 area has been matted.
